A LIMITED EVALUATION OF ULTRASONIC SPOT WELDS

IN X2020-T6 ALUMINUM ALLOY SHEET

REPORT	A461	SERIAL N	10. 3

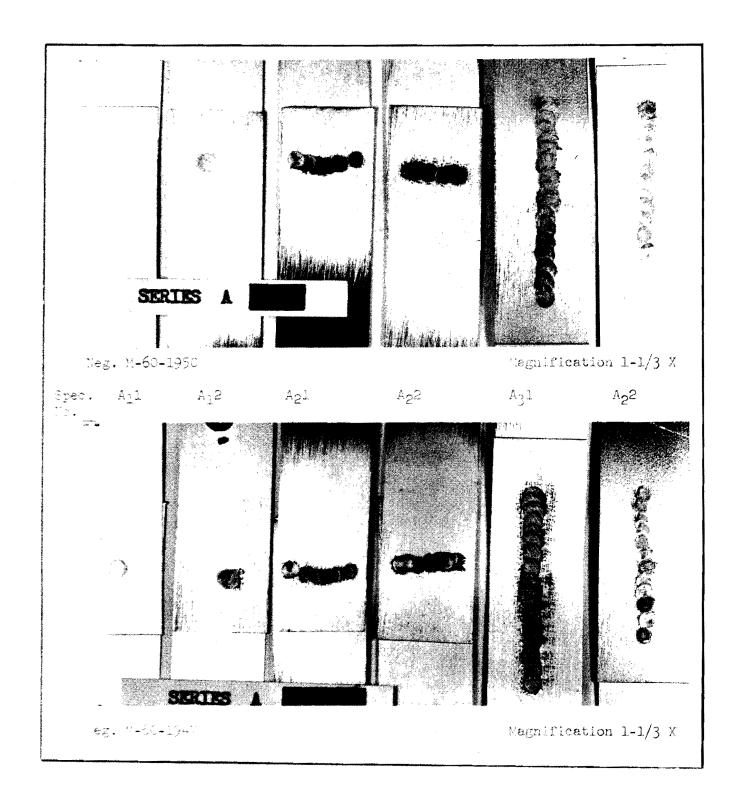
FIGURE 1

ULTRASONIC WELD CONFIGURATION OF .010" TO .010" SPECIMENS SHOWING BOTH FACES OF WELDS

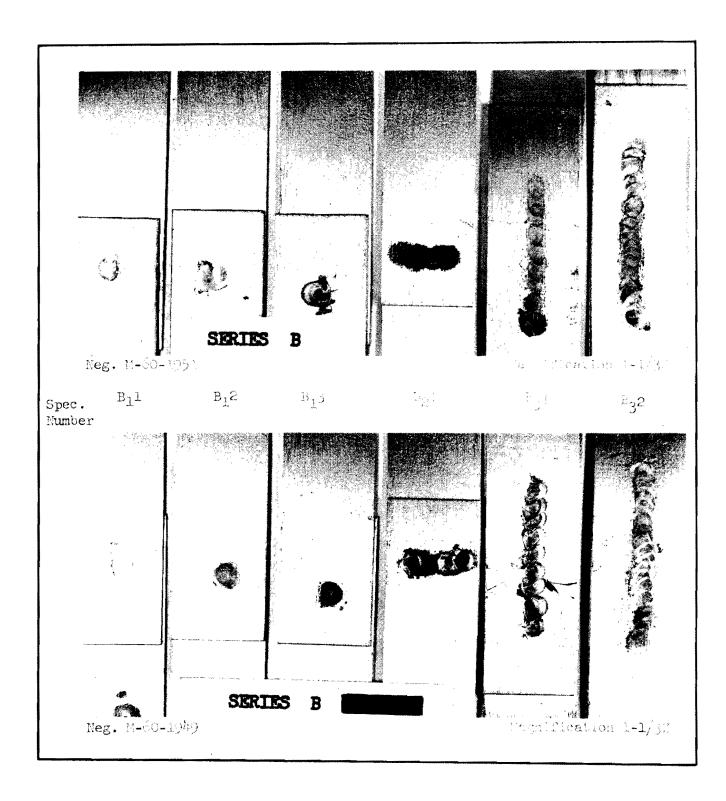
FIGURE 2

ULTRASONIC WELD CONFIGURATION OF .025" TO .025" SPECIMENS SHOWING BOTH FACES OF WELDS

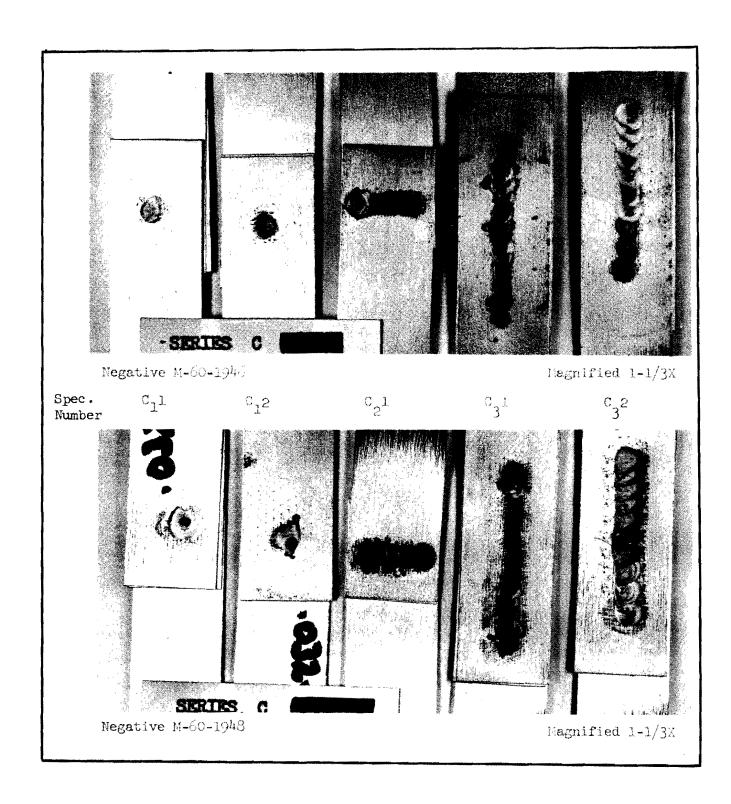
FIGURE 3

Other than tiny pits caused by sonotrode pick-up, and the flaking caused by sonotrode movement, the only visible defect was a crack from the specimen edge to the first spot of one of the .010 + .010 to .032 specimens which had the overlapping spot seam weld running across the 3/4" specimen width. This crack was apparently caused by an edge distance too short for the pressure and power used. The crack did not extend into the weld. See Figure 3, Specimen C₂1.

ULTRASONIC WELD CONFIGURATION OF .010" + .010" TO .032" SPECIMENS SHOWING BOTH FACES OF WELDS

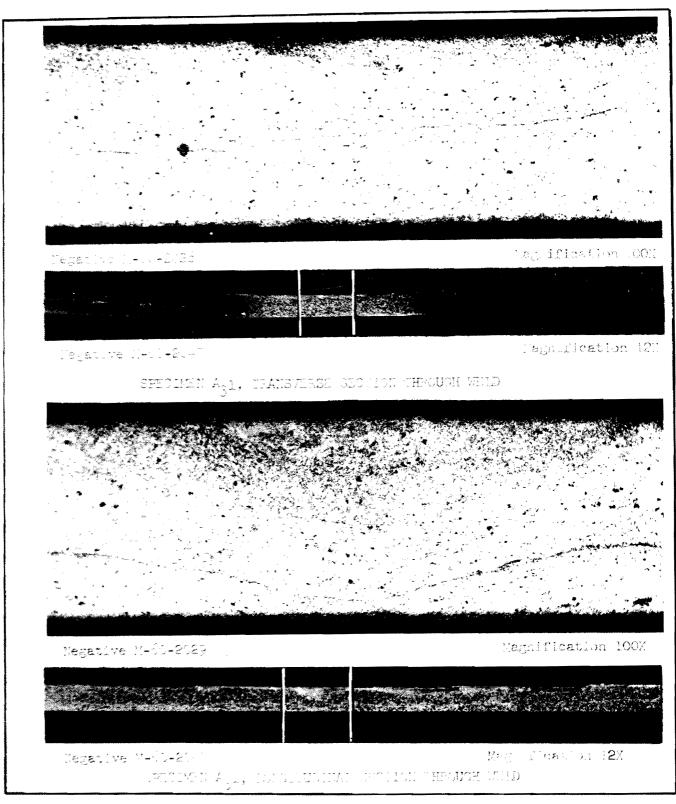
FIGURE 4

One phenomenom of this method of joining is the tendency of the interface line to drift in an irregular manner, as shown in Figure 4, without significant change in overall material thickness. One explanation offered is that possibly the grains lose their cohesion during the ultrasmic vibration and act like a bowl of sugar in the weld section, permitting some freedom of movement for reorientation of grains and displacement of the broken oxide film.

METALLOGRAPHIC STUDIES OF WELD CROSS SECTIONS SHOWING INTERFACE DRIFT

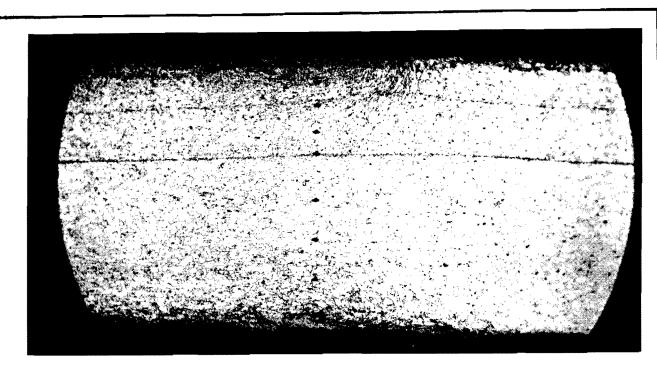
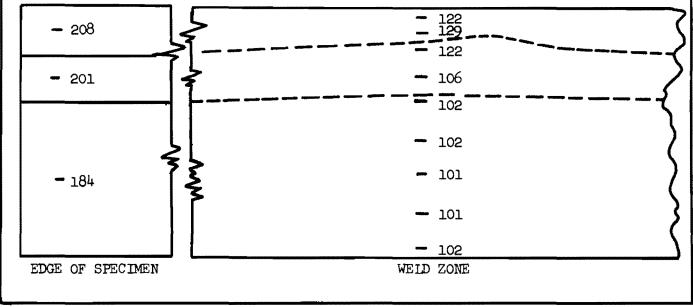
FIGURE 8

These tests were made on a mounted transverse cross section of specimen C₃1, Figure 8. The results recorded on Figure 8 show a loss in hardness rather than work hardening. Figure 12, (M-60-2104), Specimen C₂1, shows the sub-surface condition magnified 250 times.

TRANSVERSE CROSS SECTION OF SPECIMEN ${\rm C_{3}l}$ MATERIAL - X2020-T6 ALUMINUM ALLOY, .010" + .010" TO .032" SHEET

TUKON HARDNESS RELATIONSHIP OF WELD ZONE AND BASE METAL. LARGER NUMBERS INDICATE GREATER HARDNESS.

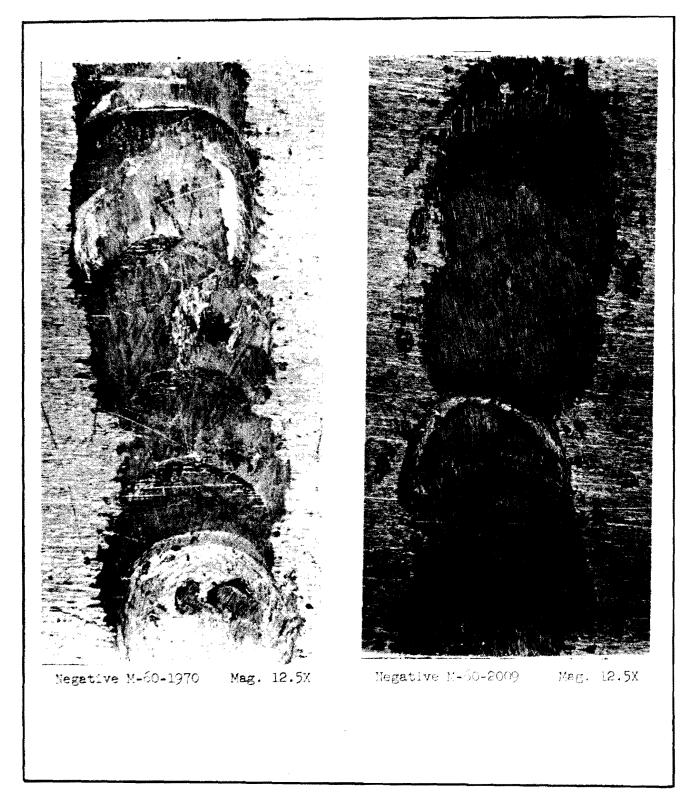
FIGURE 9

VIEWS OF BOTH SIDES OF ULTRASONIC OVERLAPPING SPOT SEAM WELD IN X2020-T6 ALUMINUM ALLOY, .010" TO .010" SHEET

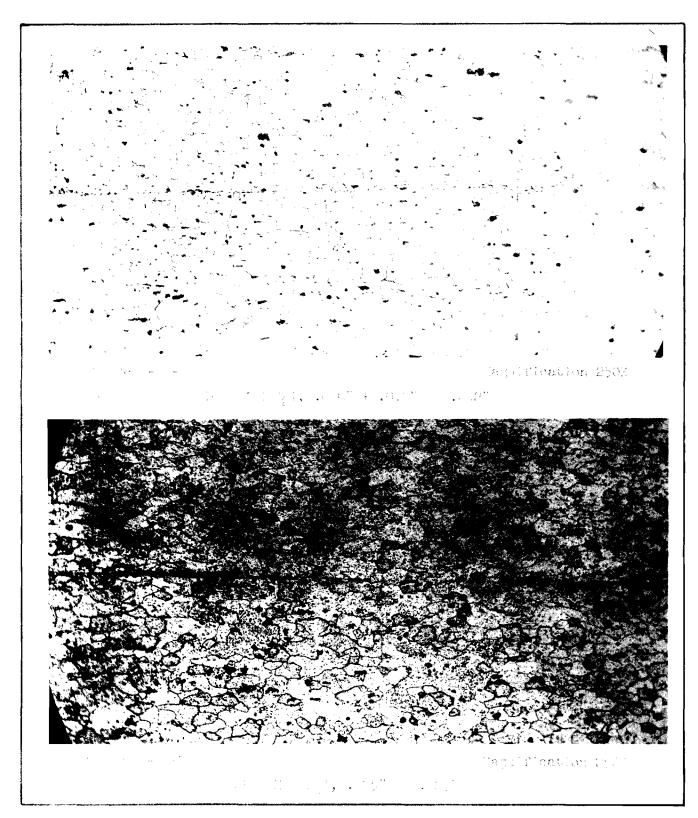
FIGURE 11

Weld grain structure at the material face and at the weld interface are shown in Figures 11 and 12.

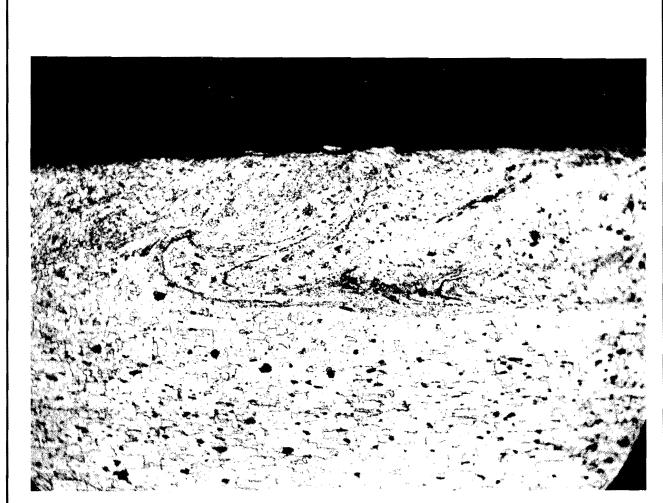
FIGURE 12

The higher magnification of Figure 12 (M-60-2104) shows that, rather than cold work, the surface condition is caused by an extremely agitated grain structure, sometimes forming eddies or swirls in which grain boundary material is accumulated. Examination of micrographs of the etched specimens indicates that the grain boundary material is affected by ultrasonic energy. In some instances there is considerable refinement of the grain structure; however, in general, at the weld interface there is no significant change in grain shape or size.
